**No-fines concrete housing insulation and air-tightness project,
Halton, Cheshire
Riverside Housing Group**

Technical Evaluation Report

CP779

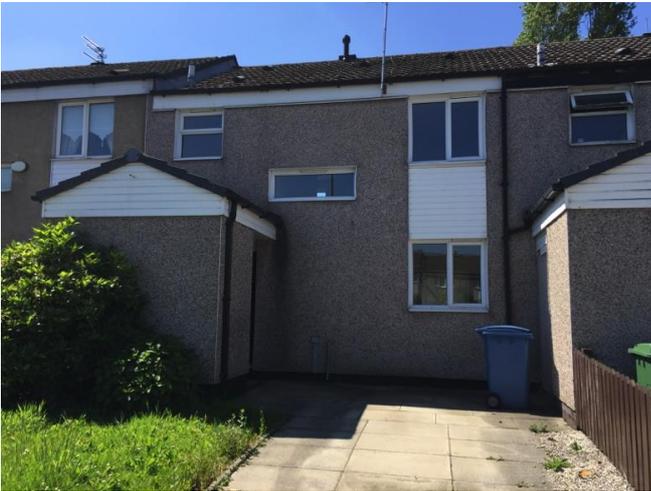
Figure 3 Typical 'No fines' terraced property, indicating the terraced and stepped nature of many of the properties together with the impact of outriggers on the front / rear of properties.

The properties are a mixture of 2 & 3 bedroom units and are either orientated NW/SE or NE/SW. House type A is a 2 bedroom property whilst types B & C are 3 bedroom properties with differing arrangements. The properties are either end-terraced or mid-terraced. In order to protect the privacy of the residents, data in the study has been anonymised, each being allocated an identification number. The numbers 1-31 are the identifications following (T) in the technical reference numbers. The group sizes differ due in part to the rearrangement of groups part way through the projects, but also to reflect the range of differences in issues to be investigated. For example, there are more combinations of measures in Group 3 than Group 1. Group 4 is small because of the refusal by participants to accept internal wall insulation due to the potential impact on their interiors.

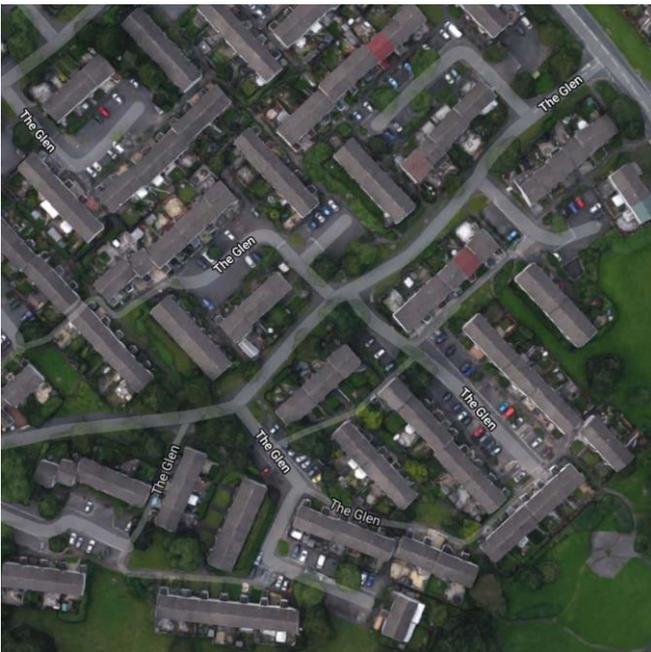
Figure 4 Extract of site layout showing arrangements of terraced blocks. Note the block sizes, stepped arrangements and outrigger positions.

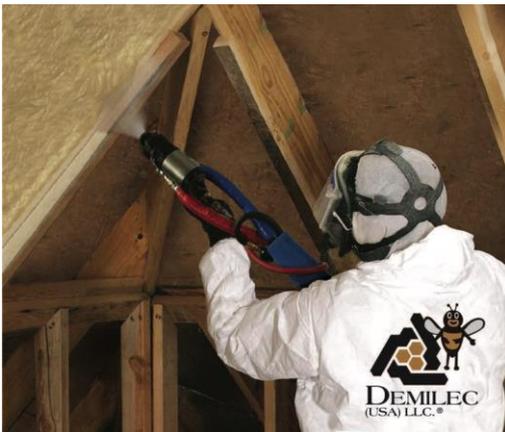
Figure 28 Installing Demelec Insulation

Demelec Sprayfoam is a non-polyurethane (PU) soft-foam open-cell insulation with a declared thermal resistivity of 0.039 W/M²K R-value that expands on application to provide an airtight but vapour permeable barrier to 'hard to treat' areas. This product was applied to the underside of roof, into the eaves, across gables and part walls within roof voids. Demelec is relatively new to the UK market and is not yet widely recognised for its air tightness qualities. It has a water vapour resistance factor of 6²²

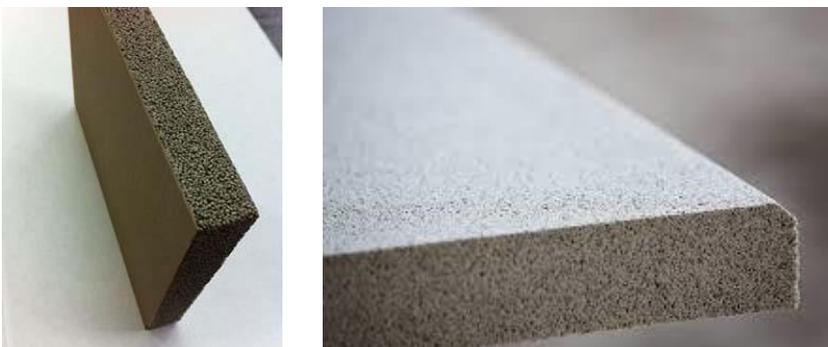
Figure 29 Quietstone Q-Clad Pre-rendered below damp insulation & Window thermal break board

Q-Clad Thermal Break is a structural foamed glass bead insulation board developed by Quietstone⁽¹⁹⁾ for uses as a thin profile window liner. Its purpose is to provide a thermal break to solid wall window replacement installations without reducing the area of glazing. The required slenderness of the retrofit measure necessitates use of a structurally stable material that does not fracture during installation. The product is a new technology designed to address this issue.

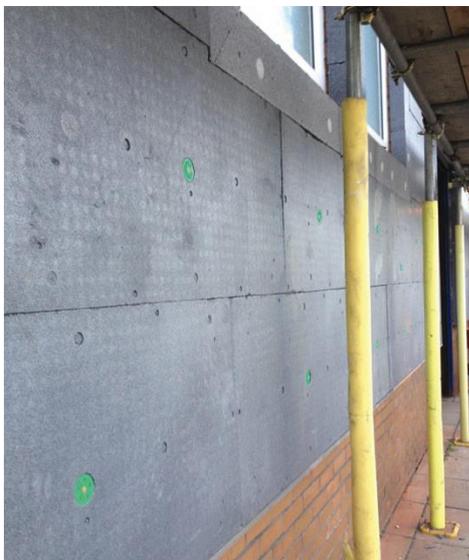
Figure 30 Jablite Dynamic Insulation Installation & ventilation regime diagram

Jablite Dynamic EWI^{25 26} is a two layer vented insulation product that uses the heat energy conducting through the walls to warm air that is brought in through a channel at the bottom of the insulation. The air is brought into the property via a Passive Input Ventilation System connected to an air plenum at eaves level. The input air temperature is naturally raised by 7°C when the external temperature is more than 10° below the internal air temperature. The benefit of this measure is that ventilation is pre-warmed and the thickness of EWI required is significantly reduced. This insulation is to be installed in conjunction with Insuletics Render Systems, inclusive of thermal break treatments for satellite dishes, porch canopies and meter boxes. Jablite Dynamic with Envirovent PIV⁽²³⁾ is a new technology particularly suitable for a retrofit installation that improves air tightness.

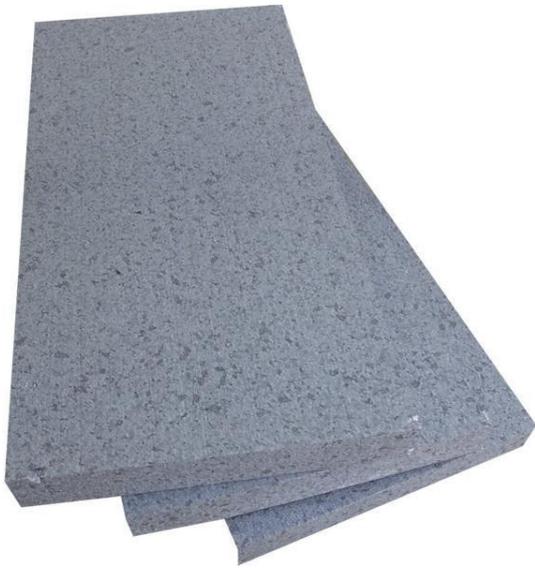
Figure 31 Jablite Classic Insulation Board

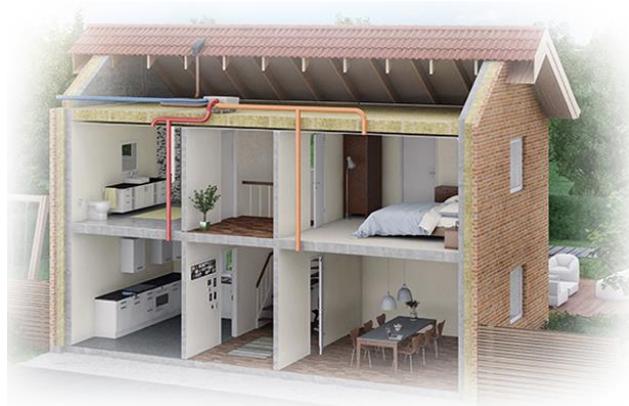
Figure 32 Envirovent MVHR unit and installation diagram showing typical location of vents

EnviroVent Positive Input Ventilation (PIV) is a centrally-located, loft mounted unit that supplies filtered air at a controlled rate. This technology compliments the Jablite Dynamic insulation as the input air is pre-warmed. The input air for the unit is connected to the eaves collection plenum for the insulation system and the associated input and extract ductwork is ducted through the central store / cylinder cupboard and adjacent ceilings.

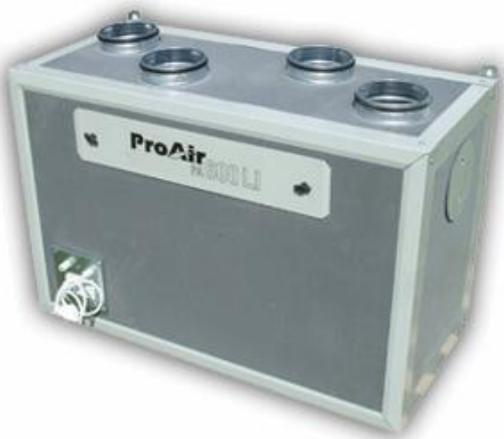
Figure 33 Pro Air MVHR

Pro-Air MVHR units are designed for larger / colder properties and provide an alternative to Envirovent MVHR in terms of flexibility and efficiency.

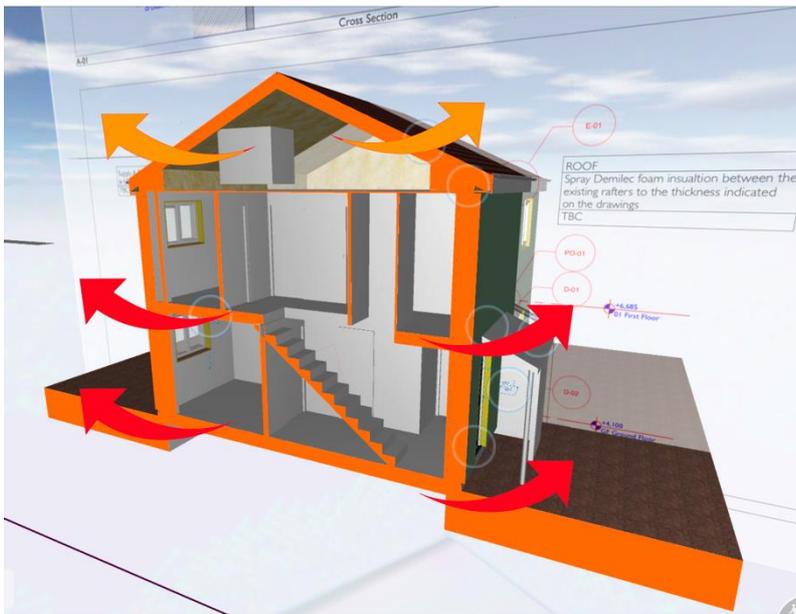
Figure 35 Section showing key areas of heat loss at cold bridge points identified through thermography

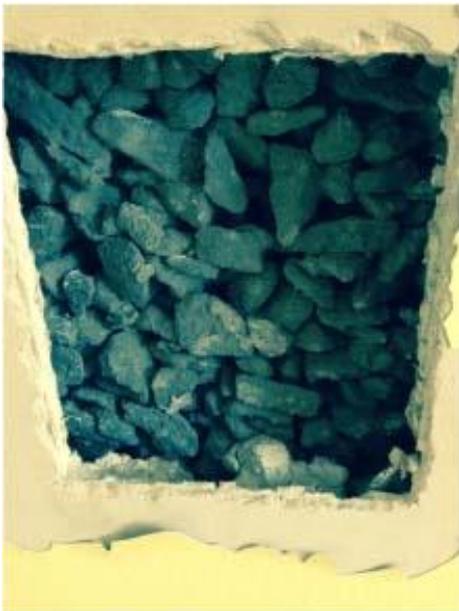
Figure 37 No Fines concrete exposed in the wall

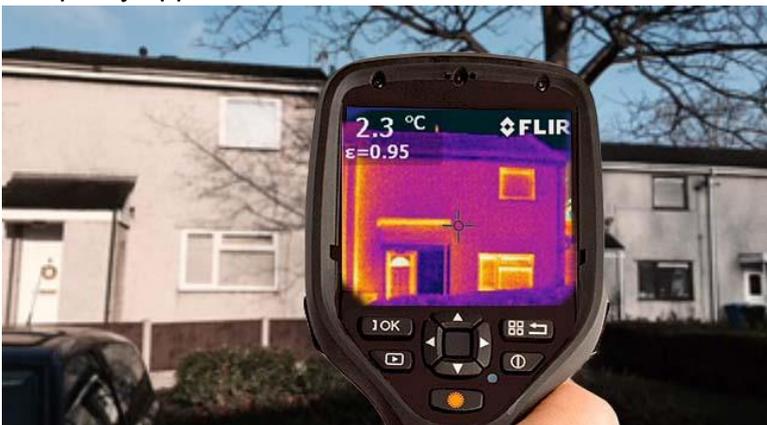
Figure 41 Flir B50 Thermal Imaging Camera in action

A Flir B50³⁴ thermal imaging camera was used according to BS EN 13187 to identify thermal bridges, air flow within the walls and areas at risk from condensation, mould and damp. Details identified through this process were modelled and addressed using Graphisoft's ArchiCAD³⁵ Building Information Modelling Authoring Software and EcoDesigner³¹, a software add on to enhance energy modelling capabilities. The ArchiCAD (BIM) and EcoDesigner (Energy Modelling) outputs were calibrated with baseline Air Pressure tests and Thermography. The empirical results could then form a basis to inform decision making for this and future stock improvements in a way that could be strategised to incorporate progressive maintenance that can respond to funding and policy opportunities.

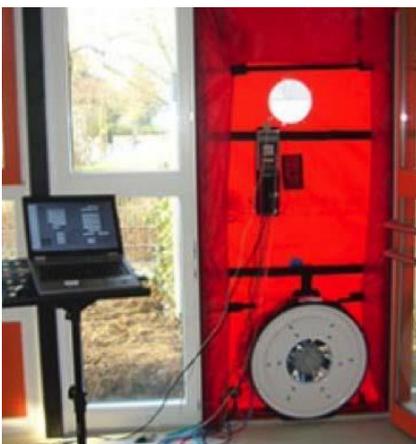
Figure 42 Air Pressure test equipment showing the door seal and depressurisation fan

A sample of properties had air pressure tests carried out before and after the installation of measures. Peak Acoustics³⁶ carried out the key tests in accordance with ATTMA TS1³⁷. The properties are de-pressurised to create an air pressure differential of 50 Pascal (50N/m²) between the inside and outside. The air leakage rate per hour per square metre of building envelope area at the test reference pressure differential is then measured. It is possible during these tests to identify the main location of air infiltration / leakage as the pressure differential causes noticeable airflow. The tests were carried out across 15 properties with interim testing on the first trial (pilot) property to assist with optimising detail installation, in particular the spray-foam insulation.

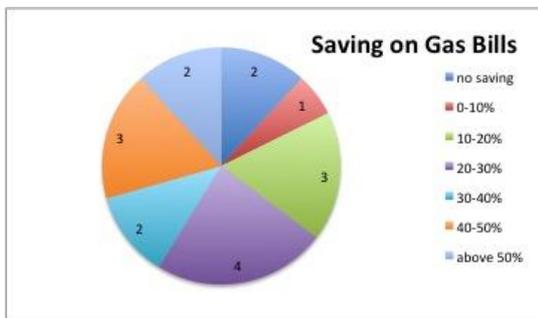
Figure 44a Percentage saving on gas bills (10% increments)

Percentage savings by number of properties were on gas costs in 10% increments are shown in Figure 45a and the average percentage savings on energy bills are shown by group in Figure 45b.

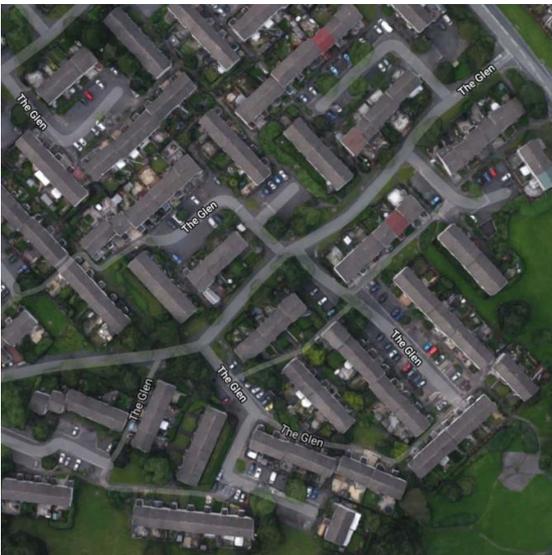
The satellite image⁴⁷ and site plan showing properties at the Glen. Almost half are under control of The Riverside Group, but the majority are not located in contiguous blocks. This illustrates the terraced and stepped-terraced arrangement of houses. The rationale for retrofitting whole blocks is particularly pertinent for no-fines concrete houses due to the connected voids in the walls between adjacent properties. The potentially difficulty of organising whole-block refurbishment given the mixed tenure inherent on this estate is highlighted by the layout.
