Increasing self-consumption of solar PV: Analysis of long-term performance of domestic solar PV installations

Paul Rogers and Michael Hamer

January 2023

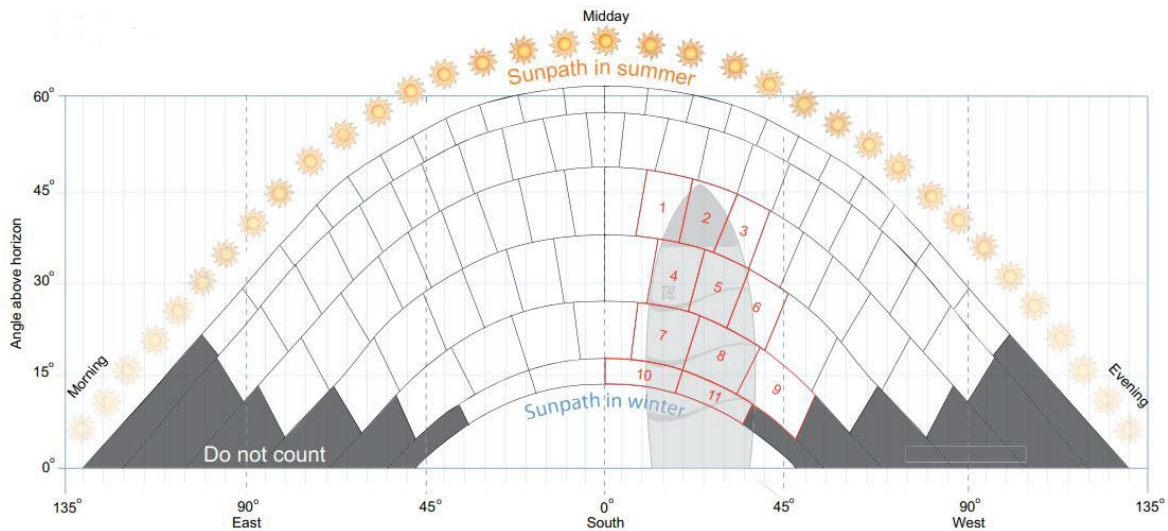
Figure 3.3 Sun path diagram showing an example shading assessment (From MCS Solar PV Shade Evaluation Procedure)⁴

Figure 3.3 shows an example sun path assessment. The diagram has 84 segments which each have a value of 0.01. In order to calculate SF, you first count the number of segments which are affected by the object. In the case of figure 3.3, this is 11 segments.

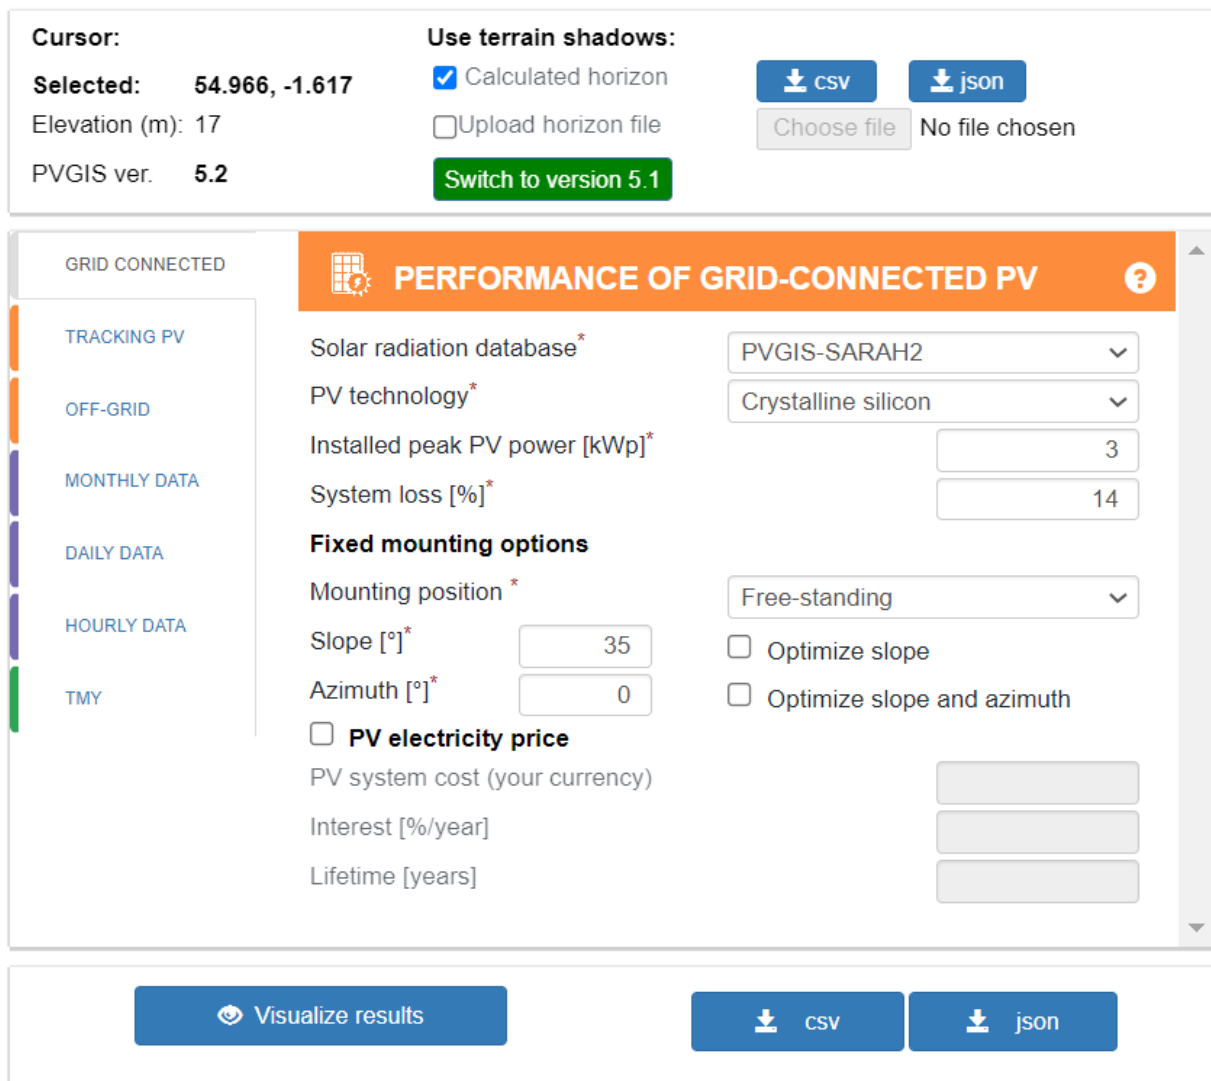
Figure 3.4 Data entry for PVGIS calculation (From https://re.jrc.ec.europa.eu/pvg_tools/en/ Accessed 27 Jan 23)

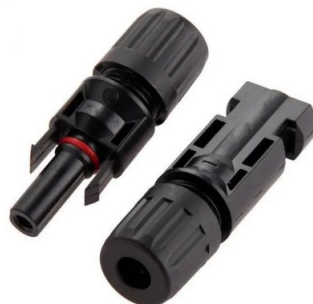
Figure 5.2 Male and female MC4 connectors which are used on solar panels

Damp getting into the MC4 connectors is a more likely cause of a fault than the failure of the panels themselves.

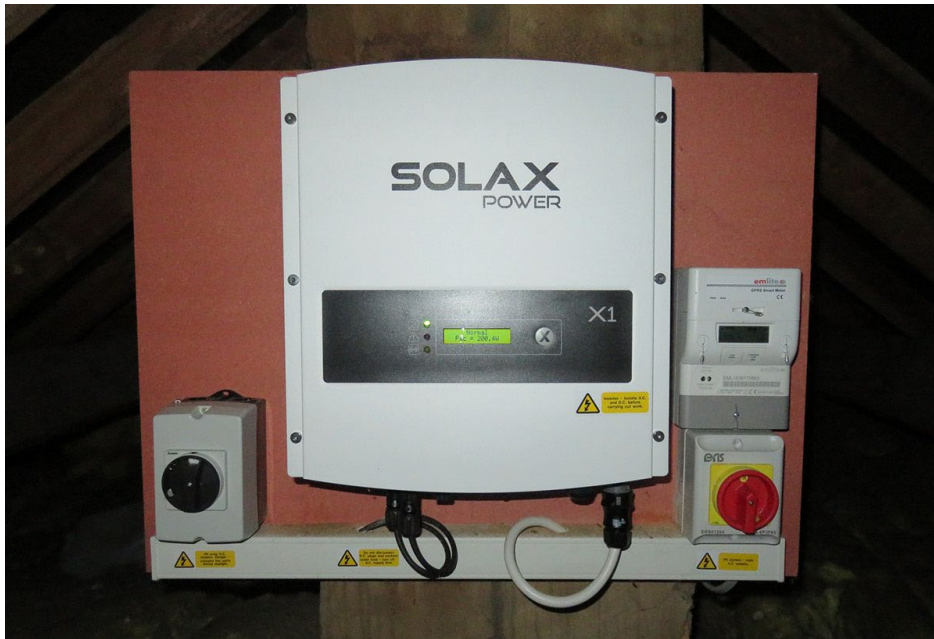
Figure 5.3 shows an example of a SolaX inverter fitted in the loft of a socially rented home. On the left of the inverter is the DC isolator and on the right is the AC isolator with the smart generation meter above it. Much of the cabling has been fitted in plastic trunking.

Figure 5.3 SolaX inverter with the DC isolator, AC isolator and smart generation meter

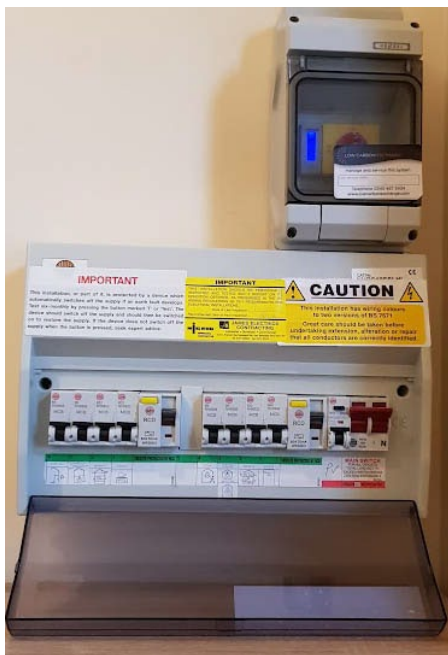
The solar PV installations on the new build homes in Barnstaple had the inverters fitted in the loft. The AC isolator and generation meter was fitted in the consumer unit or in a separate enclosure next to the consumer unit (figure 7.3).
